# MICROGUIDE DISCOVERS MAJOR ANOMALY IN WELLBORE & ACCURATELY PLACES ROD GUIDES

Canadian, Texas

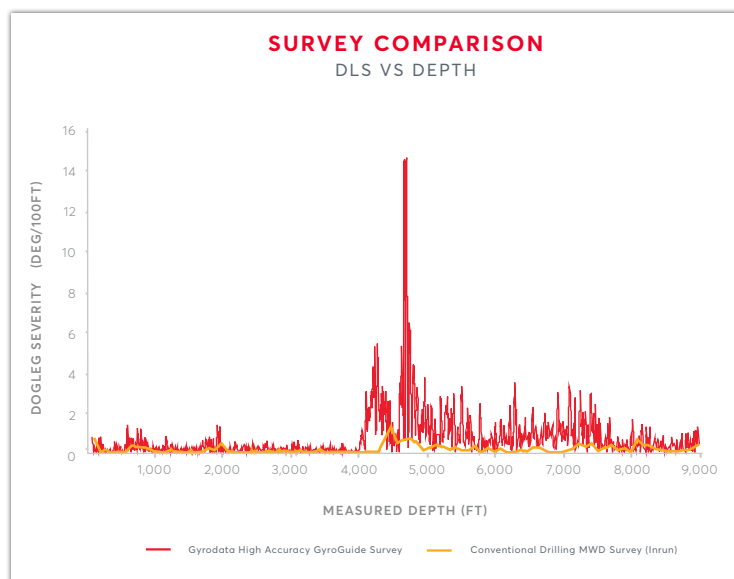
The detailed DLS vs Depth analysis provided by the MicroGuide service indicated between 4,640-4,690 ft the DLS was ~15°, compared to the original drilling survey stating no more than ~1°. The large DLS in this portion of the well was determined to be the root cause of the premature failure, and a new location was recommended for the future rod guide placement.
