CASE STUDY

COMBINED SINGLE RUN OF MICROGUIDE™ WITH INTEGRITY LOG ALLOWED COMPLETION BHA REDESIGN AND IMPROVED PACKER PLACEMENT

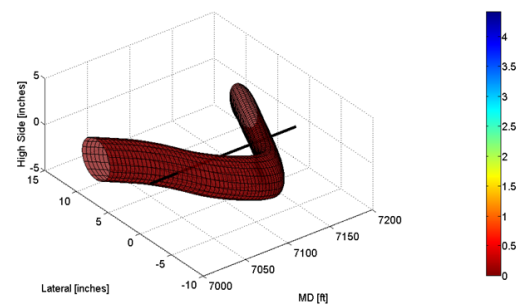
MicroGuide™ analysis

- The MicroGuide analysis was performed in combination with integrity tools in a single run to save rig time.
- After examining the MicroGuide analysis, we determined that the issue was tortuosity and that there was no major concern with the integrity of the casing, as there had not been a collapse.

3D representation of transversal displacement. Color temperature is proportional to the maximum diameter of device in inches. At a Measured Depth of 7098.0 ft, the maximum diameter of a device is 0.00 inches, at a device bend of 0.000 degrees / 100 ft. For a device of diameter 4.00 inches, a uniform bend below the allowed maximum was not found.

- MicroGuide revealed that the operator needed to change the original completion string with another one, as the original was not long enough to pass through this depth.

- MicroGuide provided the information necessary to place the ESP requirement in the best zone in order to get it straight and avoid problems due to buckling.

- The complementary integrity analysis suggested that the operator place the packers 30 ft above the planned location, as the casing in that area was in better condition.
