CASE STUDY

MICROGUIDE REVEALS MAJOR ANOMALY IN WELLBORE AND ENABLES ACCURATE ROD GUIDE PLACEMENT

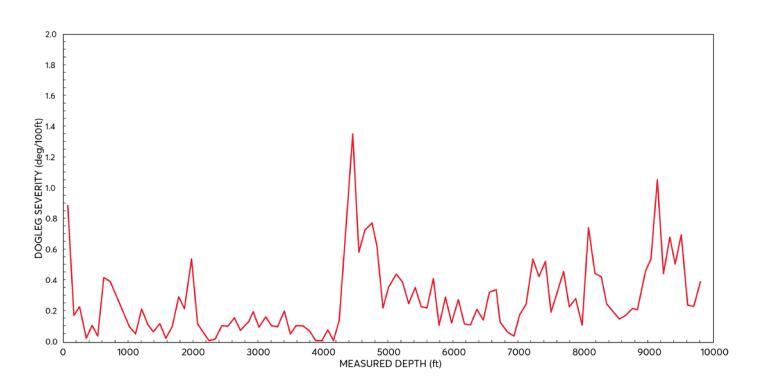
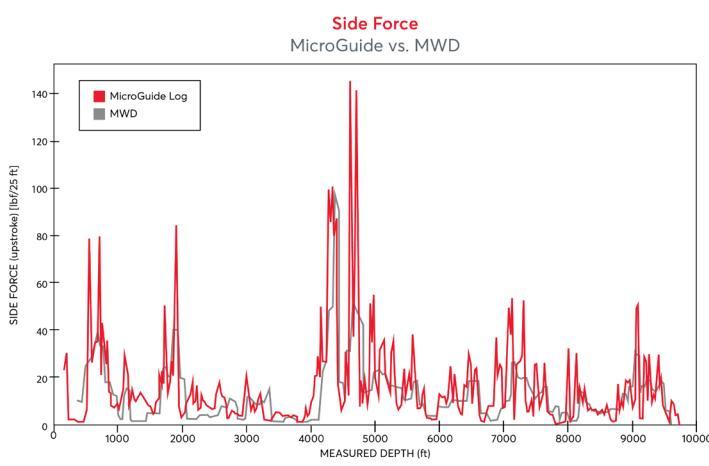
- □ The initial dogleg severity (DLS) analysis provided by the MWD equipment stated that the DLS was no more than approximately 1° throughout the section (see leftmost image below). DLS alone, however, does not provide a full picture of everything going on downhole, but MicroGuide also calculated side force. Additional areas of high tortuosity were apparent between 4,640 to 4,690 ft (see rightmost image below), and this high tortuosity was the root cause of the rod pump system's premature failure.

A major operator's well with a rod pump artificial lift system went down after just one week. The operator discovered there was excessive damage to the rods, which they had parted at 4,700-ft MD.

The cause of the damage was unknown, and the drilling surveys hadn't indicated any red flags at the depth originally selected for the rod guide placement.

- □ With the higher density data and obstruction analysis provided by MicroGuide, the customer gained a clearer understanding of the wellbore's profile, enabling them to better position the rod guides. This ultimately maximized production and greatly extended the life of the well-over 2 years to date.
- □ Significant cost savings were also delivered by avoiding the average three workover operations required a year due to the premature failures and associated lost production.
