High-Resolution Wellbore Tortuosity Logs Improve Completion and Production Equipment Placement

Rob Shoup, Justin Boltz, and Stephen Forrester, Gyrodata

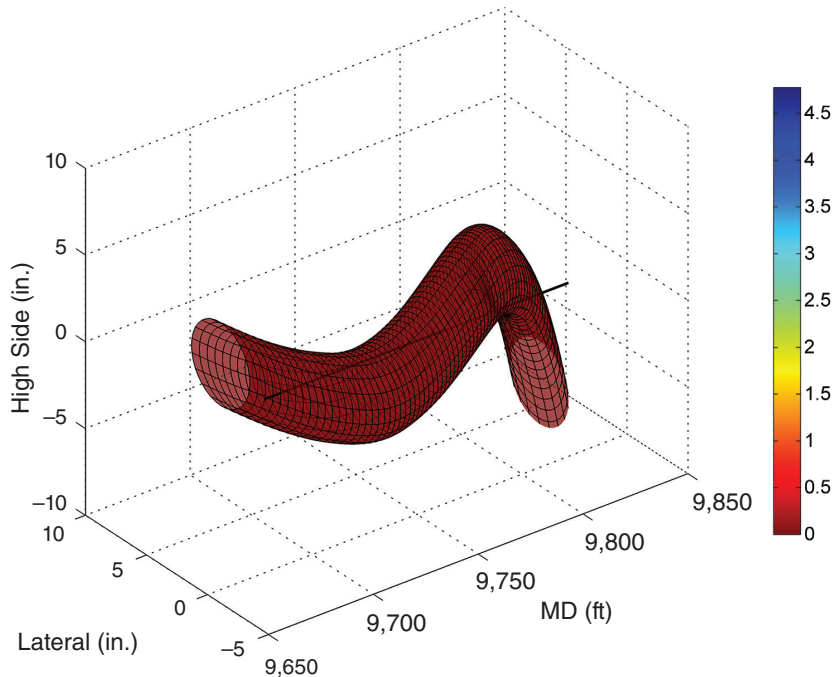
3D representation of transversal displacement. Color temperature is proportional to the maximum diameter of device in inches. At a measured depth of 9,750 ft, the maximum diameter of a device is 0.00 in., at a device bend of $0.000^\circ/100$ ft. For a device of diameter 4 in., a uniform bend below the allowed maximum was not found.

Fig. 1—The top graph illustrates that the device could not be placed at the proposed set depth based on MWD data. The bottom graph shows the placement based on Gyrodata's recommended set depth of 10,100 ft.

Gyrodata ran a high-resolution wellbore tortuosity analysis, producing data on tortuosity, total displacement, and maximum diameter of the device. The system was run from surface to 10,300 ft in 5½-in. casing to log the entire vertical section of the wellbore. The operator provided specifications of a 5½-in., 20-lb casing inside diameter, 9,750-ft installation depth, and 400 series, 145-ft ESP dimensions. The analysis revealed that at the 9,750-ft proposed set depth, tortuosity was high enough to present a problem; in this area, the maximum diameter of a pump without bending would be less than that of the 400 series ESP (Fig. 1).

Gyrodata recommended an optimum set depth of 10,100 ft for the ESP based on the tortuosity analysis, allowing an additional 300 ft of depth for fluid drawdown. Gyrodata also highlighted areas of the wellbore at 495 ft and from 5,446 to 5,838 ft that could potentially cause cable issues when traversing the ESP to that depth. To account for these trouble areas, the operator reduced the tubing size from 2 $\frac{7}{8}$ to 2 $\frac{3}{8}$ in., increased the number of cable clamps, and slowed traveling speeds, allowing the operator to successfully place the ESP at the recommended set depth without damaging it. As of June 2020, the ESP was still online and had been running for more than 200 days without damage or failure.

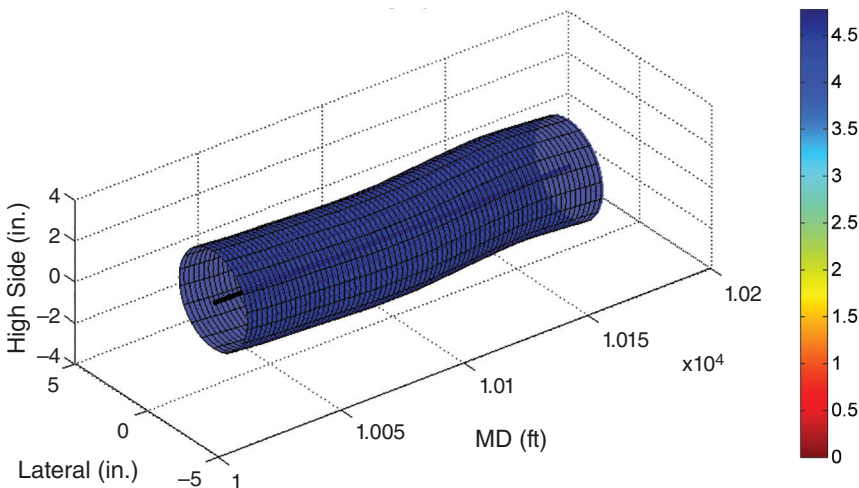
3D representation of transversal displacement. Color temperature is proportional to the maximum diameter of device in inches. At a measured depth of 10,100 ft, the maximum diameter of a device is 4.43 in., at a device bend of $0.012^\circ/100$ ft. A device of diameter 4 in. will undergo a uniform bend of $0.000^\circ/100$ ft.

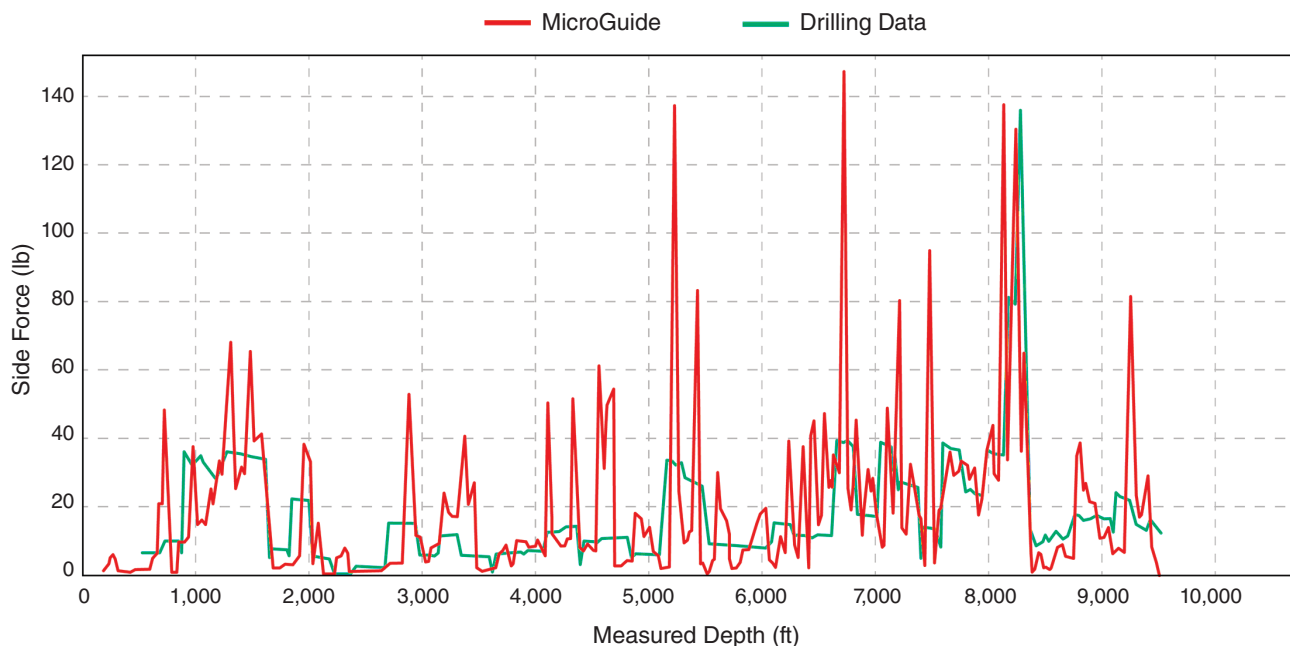
Gyrodata suggested the operator run a high-resolution tortuosity analysis to obtain a more accurate picture of what was going on downhole. After processing the collected data on tortuosity, contact points, sideloading force, and normalized displacement in 1-ft increments, the operator found a significant number of tortuosity spikes vs. what was shown in the MWD data (Fig. 2). With a complementary obstruction analysis, the optimal locations for the placement of new rod guides were discovered.

Fig. 2—In this graph, data from the wellbore tortuosity logs reveal areas of significantly higher tortuosity than previously measured with the MWD tool, helping provide a clearer picture of where sideloading forces against the tubing would not damage the rod guides.

After accurately placing the rod guides at locations downhole where sideloading forces against the tubing would not cause premature failure, the operator effectively eliminated the need for workovers, reducing the rate from an average of three times per year to going more than a year without a single

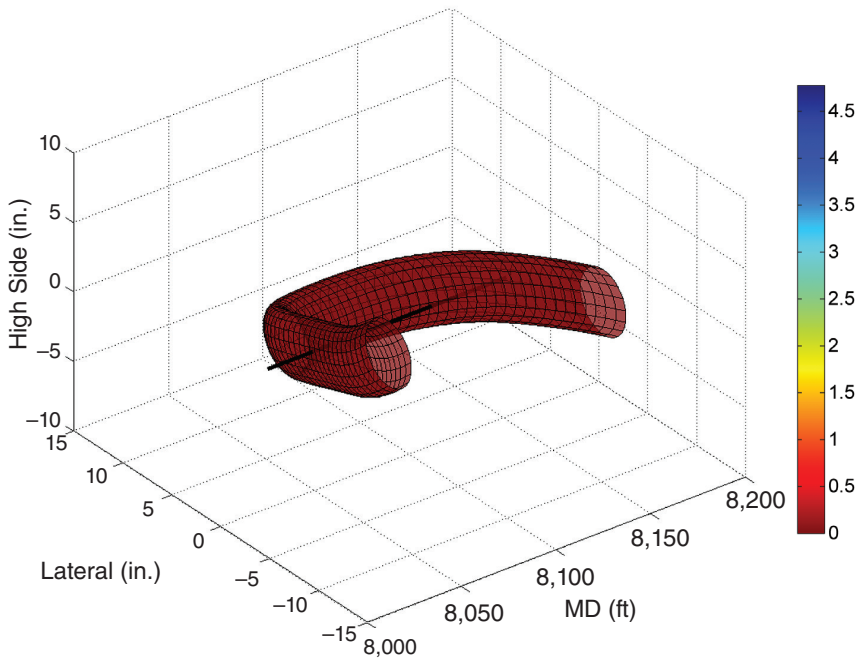
Midland Basin. An operator in the Midland Basin decided to use an ESP as the method of artificial lift in a horizontal well. The well profile consisted of a kickoff point at 8,315-ft measured depth (MD), build section to horizontal at an average rate of 9° per 100 ft, and a lateral section until 17,729-ft MD. The selected pump was 126-ft long and 4 in. in diameter. Based on dogleg-severity values derived from the initial MWD data, the operator was going to place the pump between 7,760 and 7,886 ft. Due to a tubing miscount, however, it was actually placed at 8,088 ft, which the operator did not realize until later revealed by forensic investigation. At the set depth, the pump failed after just 5 days with a broken shaft which had most likely been caused by extreme bending. The operator decided to conduct a wellbore tortuosity analysis to better understand

3D representation of transversal displacement. Color temperature is proportional to the maximum diameter of device in inches. At a measured depth of 8,088 ft, the maximum diameter of a device is 0.00 in., at a device bend of 0.000°/100 ft.

For a device of diameter 4 in., a uniform bend below the allowed maximum was not found.

Fig. 3—The top image shows a 3D visualization of the wellbore at the initial ESP placement, making it clear that a uniform device bend was not achievable in that scenario. The bottom image shows the successful placement of the 4-in. pump.

Gyrodata collected high-resolution tortuosity data to determine total displacement and maximum diameter of the straight device, providing the operator with a 3D wellbore visualization to clearly see the problem (Fig. 3). Using this analysis, the operator found that the optimal location was between 7,610 and 7,732 ft based on the pump’s effective diameter. At an MD of 7,670 ft, the maximum diameter that would allow a uniform bend was 4 in. at a device bend of 1.637° per 100 ft.

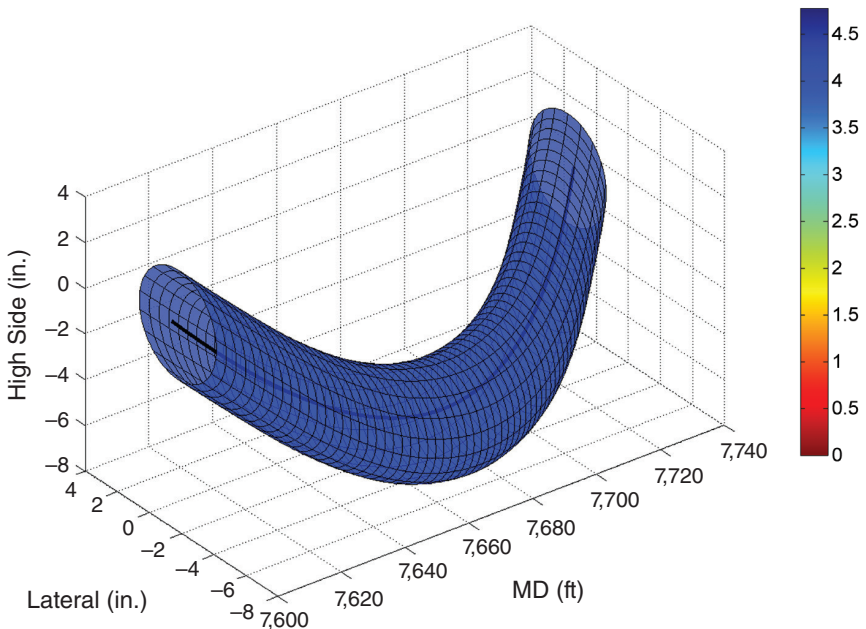
3D representation of transversal displacement. Color temperature is proportional to the maximum diameter of device in inches. At a measured depth of 7,670 ft, the maximum diameter of a device is 4.01 in., at a device bend of 1.637°/100 ft.

A device of diameter 4 in. will undergo a uniform bend of 1.637°/100 ft.

The new pump was placed at the recommended depth based on the tortuosity analysis and lasted 4 months without issue before failing. A failure analysis showed that the placement of the pump was not the issue but rather that excessive gas production in the area caused high levels of vibration. After correcting the gas issue, a new ESP was installed at the same depth, where it operated without issue for 6 months. At that point, the unit was replaced by a beam pump due to production declines in the well.
