**MORE LOGGING,  
LESS GUESSWORK**

**Rob Shoup, Justin Boltz, Matthue Ellis and Stephen Forrester, Gyrodata, USA,** demonstrate how wellbore tortuosity logging can take the guesswork out of improving artificial lift equipment placement and optimising production.

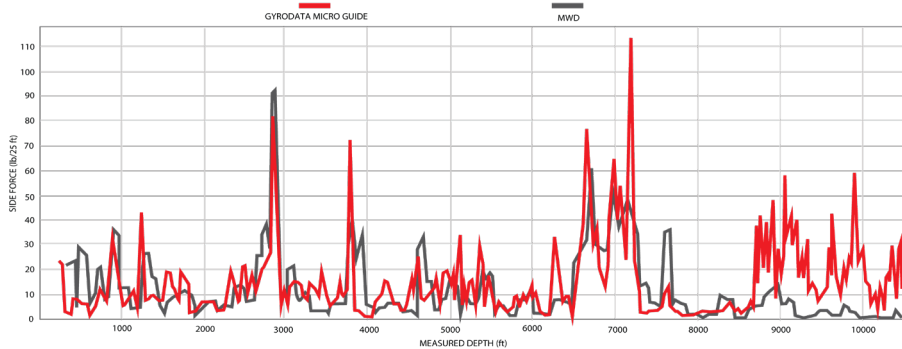
**Figure 1.** The data from the wellbore tortuosity logs revealed tortuosity spikes in several areas that were undetected with MWD equipment. In addition, the system highlighted an area of helical buckling from 8700 to 10 560 ft.

The MicroGuide analysis revealed several spikes in side force against the tubing that were not previously visible with MWD data (Figure 1). The analysis showed that the casing was helically buckled from 8700 to 10 560 ft, which was causing the increased side force throughout the section as well as the issue with rods parting. Without the wellbore tortuosity logs, the operator would have had inadequate data on the bottomhole to properly make decisions on the best artificial lift method.

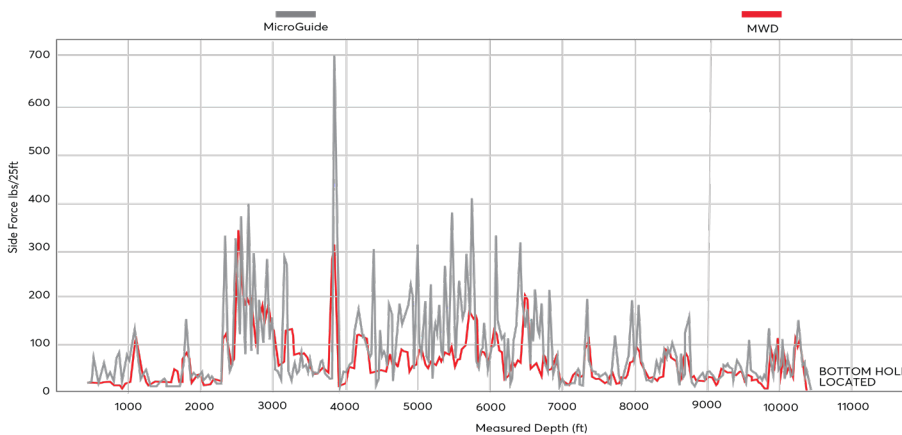
**Figure 2.** The wellbore tortuosity analysis revealed elevated side force from 2400 to 6500 ft that was not clear in the MWD data, including an extreme spike at 4000 ft.

The MicroGuide logs revealed previously unseen tortuosity from approximately 2400 to 6500 ft (Figure 2), allowing the operator to place the ESP in an optimised location without risk of premature failure. The data also showed that in the upper part of the

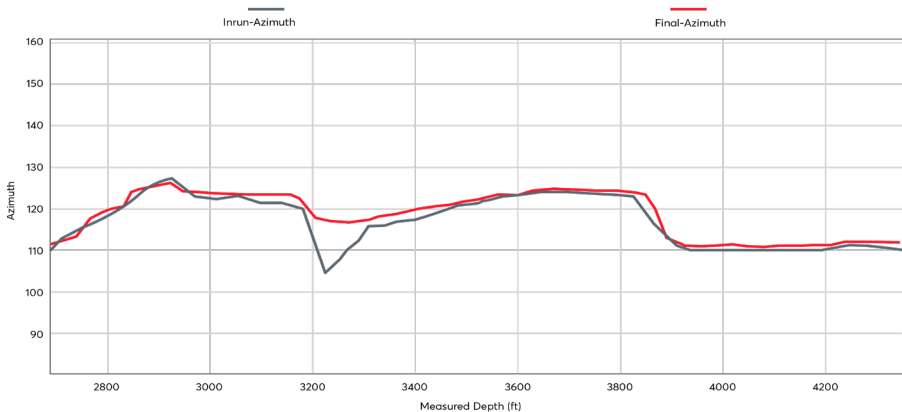
**Figure 3.** The MWD survey had an erroneous azimuth reading at approximately 3220 ft measured depth, causing a spike in calculated dogleg severity when no such spike was present in the well.

well there was an erroneous azimuth reading on the MWD survey (Figure 3) that caused an incorrect spike in dogleg severity. Had the operator used this information, they would have incorporated specialised equipment at extra cost to traverse the section, even though there was no reason to do so. To ensure that the operator could quickly shift from ESP to rod lift when production declined, they were also provided with a modelled rod guide analysis.

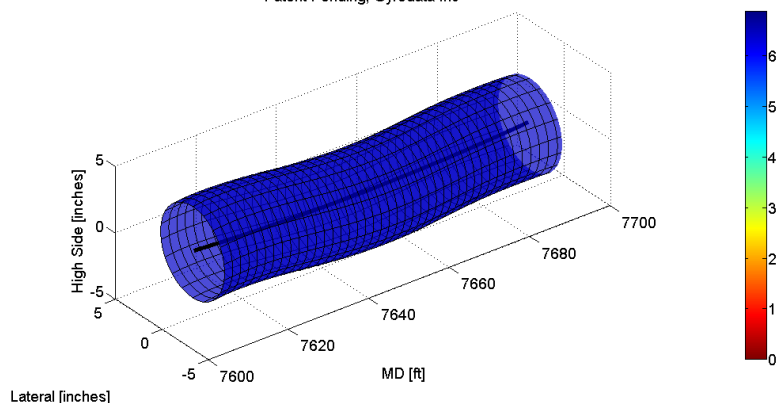
3D representation of transversal displacement. Color temperature is proportional to the maximum diameter of device in inches. At a Measured Depth of 7650.0 ft, the maximum diameter of a device is 6.40 inches, at a device bend of 0.249 degrees / 100 ft. A device of diameter 5.39 inches will undergo a uniform bend of 0.000 degrees / 100 ft. Patent Pending, Gyrodata Inc

**Figure 4.** At the new set depth of 7650 ft, there were no wellbore quality issues that would impact the production capability of the pump, and the deeper location allowed greater reservoir access.

Gyrodata recommended a deeper set depth at 7650 ft (Figure 4) to reach higher production output, noting two areas of significant tortuosity at 7135 and 7535 ft that would make traversing the pump to the new depth difficult. In addition, there was an area at 7557 ft where a 4° bend would necessitate cable clamps to pass the pump through. This would have been impossible to determine with typical MWD data and dogleg severity information; significant equipment damage would have occurred had the operator proceeded as normal.

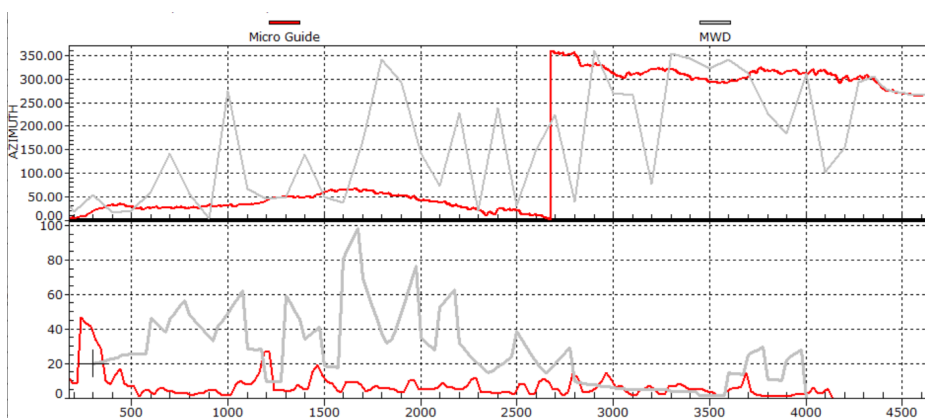
**Figure 5.** The azimuth data from gyro surveys, shown in grey, gave false appearance of tortuosity in the well (top). The analysis showed that the side force measurement calculated with the previous gyro was incorrect. Had the operator used this information they could have wrongly implemented specialised tools to place the production equipment (bottom).

azimuth readings (Figure 5, top), the use of which would have led to the operator taking a costly and unnecessary approach to placing the rod guides. The data also showed a significant variance in tortuosity versus the previous gyro surveys, with the MicroGuide logs revealing incorrect tortuosity spikes in every instance (Figure 5, bottom).
