TACKLING

TUBULAR

TRAUMA

Kris Earl and Juan Carlos Cunalata, Gyrodata, show how to maximise production through tubular integrity management.

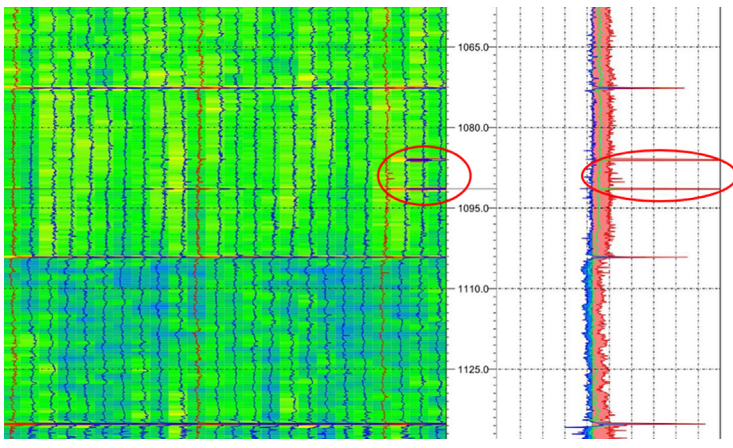
Figure 1. Corrosion log indicated that tubular #36 has 96.5% and 100% penetration values.

An operator noticed a sudden production decrease in one of its most productive wells. Additional symptoms indicated a strong case for the damage in the tubing. The operator contacted Gyrodata to run a corrosion log to verify whether there was a hole in the tubing. The corrosion log identified general corrosion throughout the well and aggressive corrosion at several intervals in the production tubing, including 100% penetration – a hole in the tubular (Figures 1 and 2).

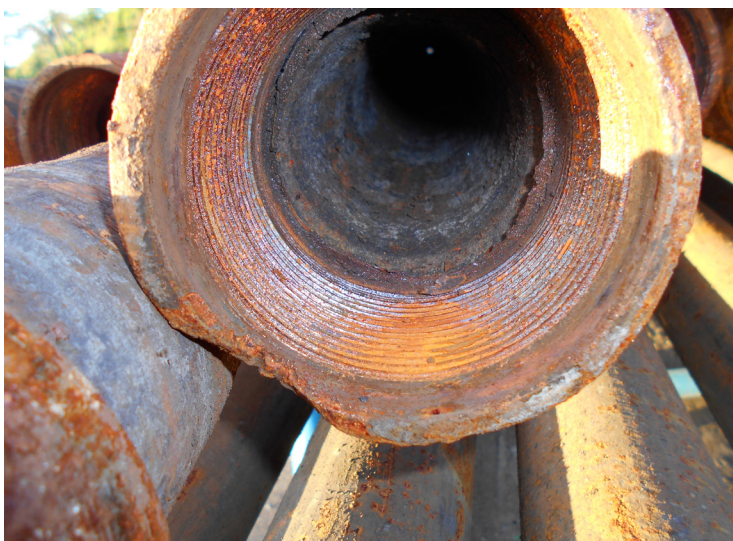
Figure 2. Further analysis of the area with 100% wall penetration.

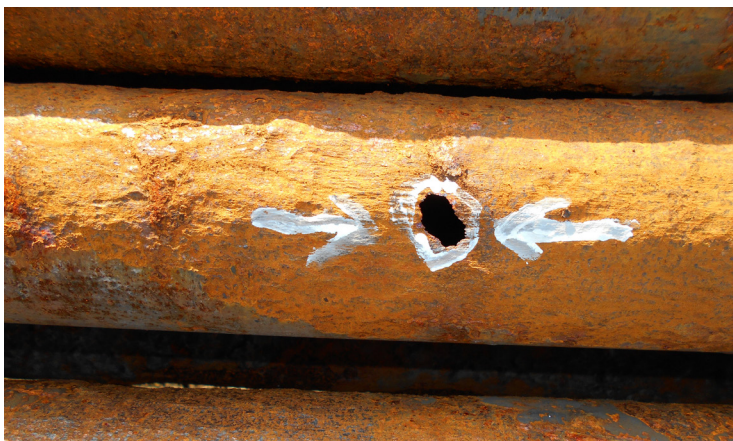
Figure 3. Tubular hole that correlates to depth identified in Figures 1 and 2.

This corrosion log also identified several tubing connections with aggressive corrosion in the collar. The operator was advised to replace those joints to avoid separation of the tubular which would have required them to fish parts of the string from the well. The corrosion identified in the connection on the log was verified visually when the tubing was pulled several months later to address an ESP failure.

The operator chose to run a wireline-set tubing patch to eliminate the need to bring out a workover rig, saving an estimated three days of production time and US\$25 000 of added expense. The ability to correctly identify whether the issue was a tubing or casing issue without having to bring out a workover rig to pull the well is estimated to have saved an additional three days of production time.
