CASE STUDY

MICROGUIDE LOG ANALYSIS ALLOWS CLIENT TO REDESIGN TWO LOGGING STRINGS AND GET INFORMATION FOR MODELING STRESS AND EXPECTED FAILURE TIME OF CASING IN WELLS DUE TO GEOLOGICAL SHIFTING

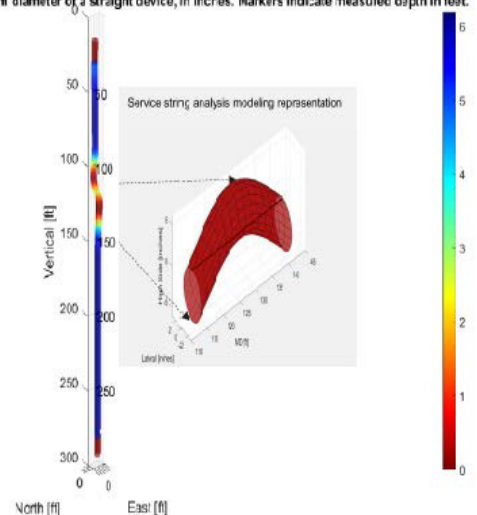
3D representation of well profile. Casing diameter and horizontal displacements are exaggerated for illustration. Color temperature is proportional to the maximum diameter of a straight device, in inches. Markers indicate measured depth in feet.

- High density data showed the three wells logged had a change in trajectory close to surface, reaching up to 6° of inclination on the section that was vertical when the wells were drilled.
- The wells have been moved up to 2 ft west in just over a 50 ft surveyed distance.
- MicroGuide™ analysis allowed in detail, the micro-tortuosity and micro-doglegs of the wells and model the current trajectory of the wells in 3D (See reference in the Fig.)
- With the MicroGuide™ analysis, the different service strings were modeled and some of them were redesigned because they could present difficulties to passing through the higher tortuosity.
