CASE STUDY

MICROGUIDE ENABLES OPTIMIZED ROD GUIDE DESIGN, SAVING \$50,000 IN REPAIR EXPENSES AND 70 DAYS ANNUALLY IN WORKOVER AND LOST PRODUCTION COSTS

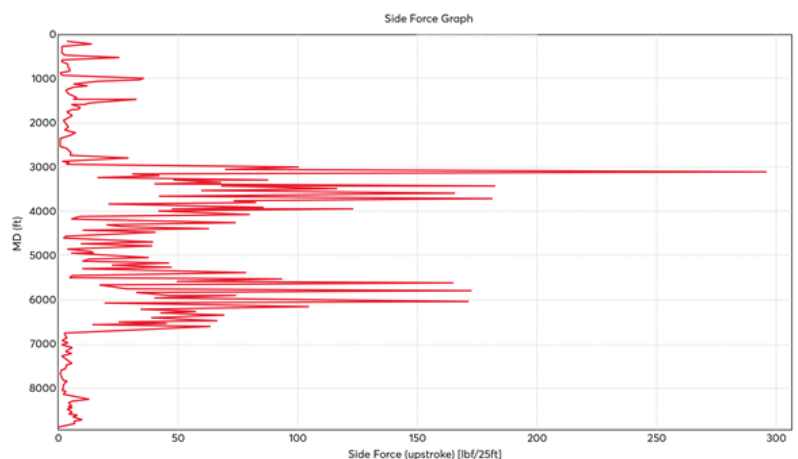
- Using the MicroGuide system allowed the operator to obtain a significantly clearer and more accurate depiction of the wellbore's condition by identifying the isolated dogleg at 3,000-ft MD.
- The high-resolution data improved modeling calculations, enabling development of a new rod guide design. After implementing the new design, the operator eliminated rod guide-associated failures.
- The system has so far saved the operator more than \$50,000 versus the original costs of repair, as well as 70 days annually in workover and loss-of-production costs and downtime.

- Initially, the operator only had single-shot data, which was showing that the well had an inclination of less than 1.7°; as such, the well was assumed vertical, which aligned with results using a traditional MWD log. Using the MicroGuide system, however, allowed surveys to be analyzed at 1-ft intervals for true high-resolution data logs.
- We identified a significant inclination spike at 3,000-ft MD, which had gone undetected using conventional MWD methods. After reviewing the tortuosity calculations from the MicroGuide system, it was clear that there were areas of compressive strength and buckling in the wellbore. These issues were causing the rod guide fatigue failures at 3,000-ft MD, where significant sideloading against the tubing was occurring.
